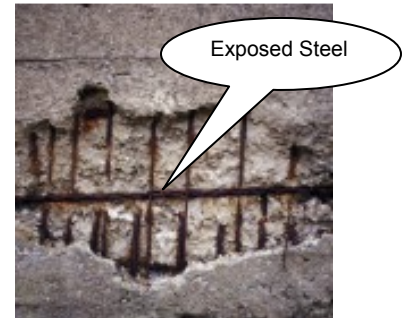
There seems to be a mystery about hydrogen sulfide and septic systems. In some areas of the country the damage related to hydrogen sulfide is severe, and in other areas it is a non-issue. Let us begin by first understanding the issues surrounding hydrogen sulfide and septic tanks. Hydrogen sulfide (H_2S) is a byproduct of the anaerobic digestion that occurs in a common septic tank. The naturally occurring thiobacillus bacteria excrete the gas during the digestion of organic material in the septic tank. The gas accumulates in the headspace above the water line in the tank, distribution box and lateral lines. When the hydrogen sulfide gas mixes with water vapor and low levels of oxygen they form sulfuric acid (H_2SO_4). The sulfuric acid attacks the concrete from which the tank and distribution box is made. Depending on the conditions, severe deterioration of the concrete can occur in a few years. Signs of deterioration are spalling of the concrete surface, white formations of ettringite (calcium sulfoaluminate) on the surface of the concrete just above the water line and exposure of rebar and reinforcing steel that was once encapsulated in the concrete. In addition to the attack of the concrete, the sulfuric acid will corrode steel components within the septic tank, such as exposed reinforcing steel, steel baffles and steel fasteners. It is our experience that water supplies with high iron and sulfur content are most prone to experience production of hydrogen sulfide.

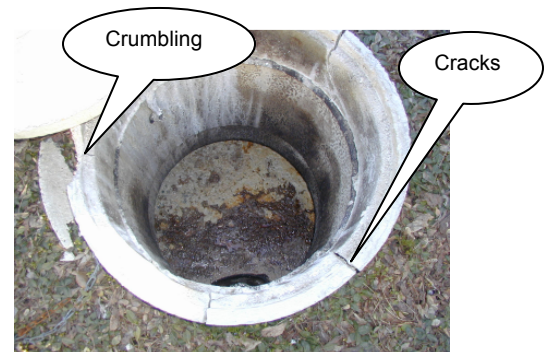
The unfortunate problem is there is no practical way to reverse the damage done by the sulfuric acid. If the structural integrity of the tank is questionable it should be inspected by a competent professional. If the tank is structurally sound your in luck! Fortunately further deterioration can be avoided by eliminating the root cause of the problem, the thiobacillus bacteria. The thiobacillus bacteria survive in an anaerobic environment (lacking oxygen). When exposed to an aerobic environment the bacteria cannot survive, thus halting the production of hydrogen sulfide. To successfully convert the environment to aerobic, the water in the tank AND the head space above the water must be oxygen rich. By installing the proven Aero-Stream® Septic Restoration process, the water and the head space will be oxygenated. All deterioration will be promptly halted. In addition to saving your tank from complete failure you will gain the benefit of extending the life of your Drainfield by preventing the growth of the bio mat. Your tank should be inspected for deterioration promptly, especially if you have high iron and high sulfur (rotten egg) odor.
